HUDSON RIVER BASIN
TRIBUTARY TO HIGHLAND LAKE
SUSSEX COUNTY
NEW JERSEY

UPPER HIGHLAND LAKE DAM

NJ 00797

PHASE 1 INSPECTION REPORT NATIONAL DAM SAFETY PROGRAM

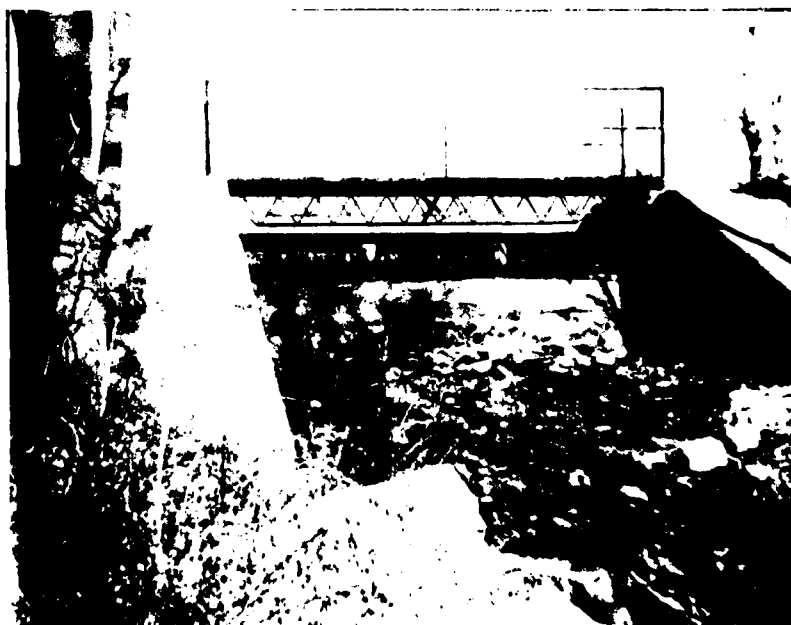
March, 1981
Downstream View of Spillway
